Manhole Inspection Summary

Manhole # S33OO_022MH

Location Address: **2410 SAINT PAUL ST**

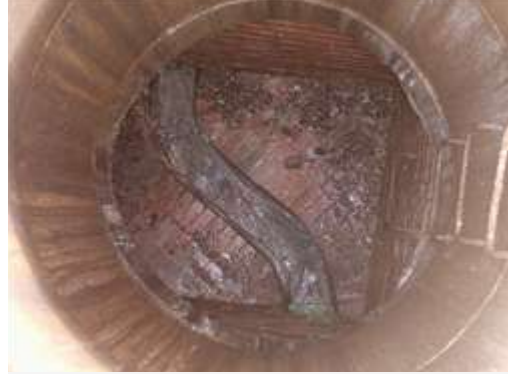
Top View

Corroded steps. Bench debris.

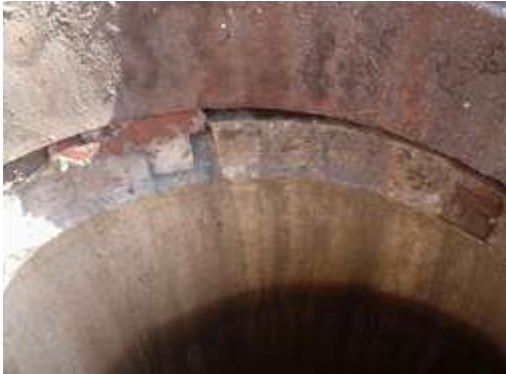
Defect

Frame leaks. Adjustment deterioration, loose brick and infiltration. Corbel infiltration - other side.

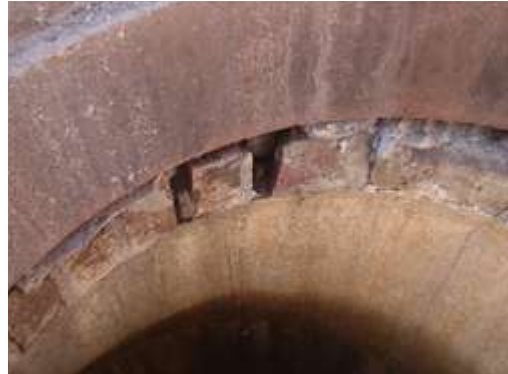
Defect

Frame leaks. Adjustment deterioration, loose brick and infiltration. Corbel infiltration.

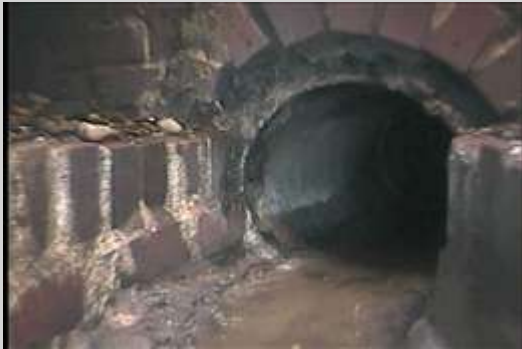
12 in. Circular Gravity Sewer Pipe Out @ 12 O'Clock

Infiltration: **Evidence** Pipe Seal Cond: **Unknown**
